# Managing a Project With Karst Geology

Chester County Engineers – Fall Conference 2021

**EARTH  
ENGINEERING  
INCORPORATED**

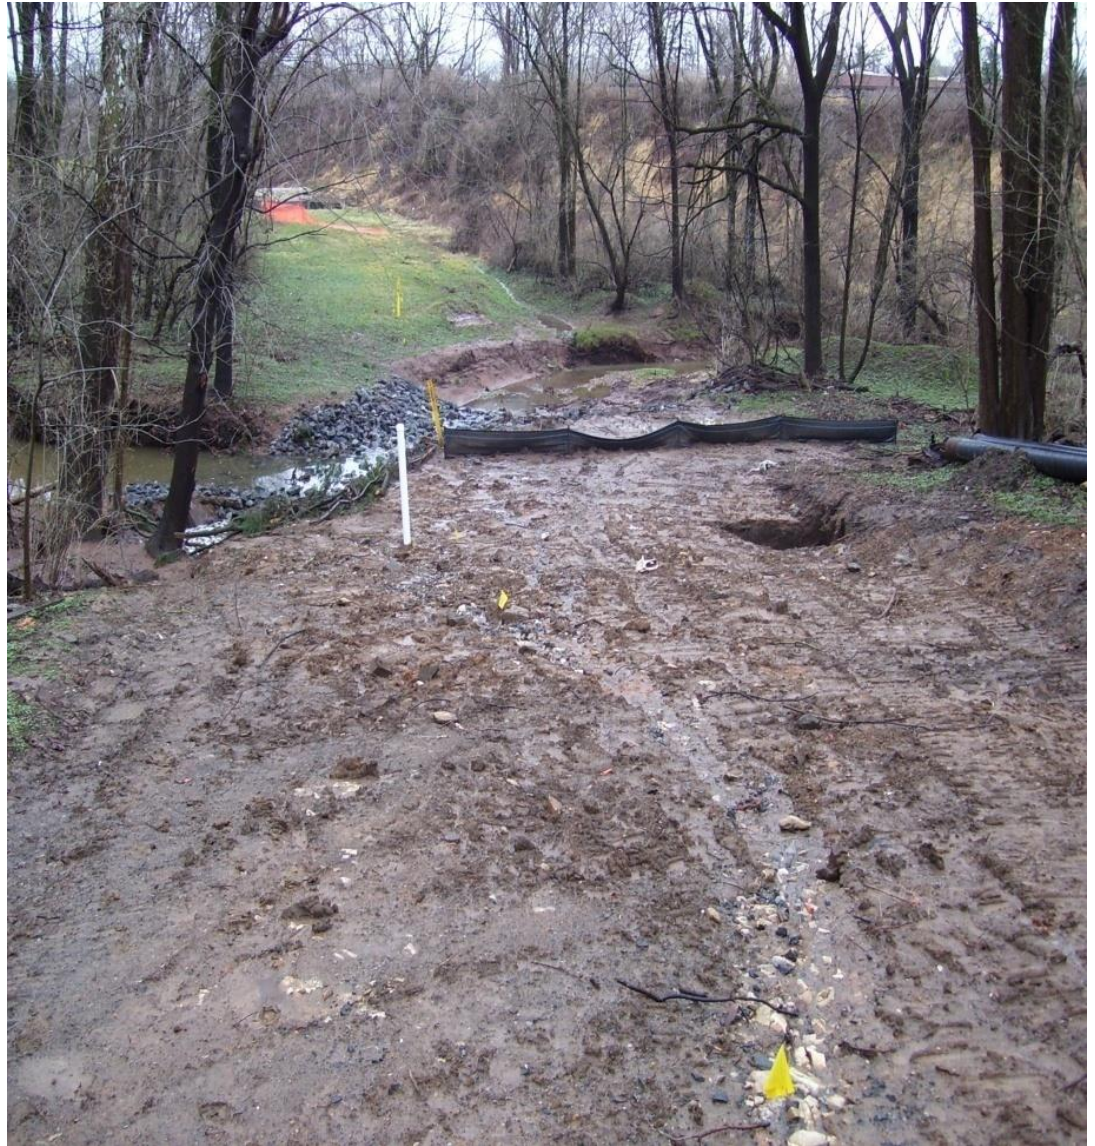
## Site #1 - Sinkhole Activity at Creek

Disappearing Stream  
condition(s) and multiple  
sinkholes adjacent to creek in  
commercial property

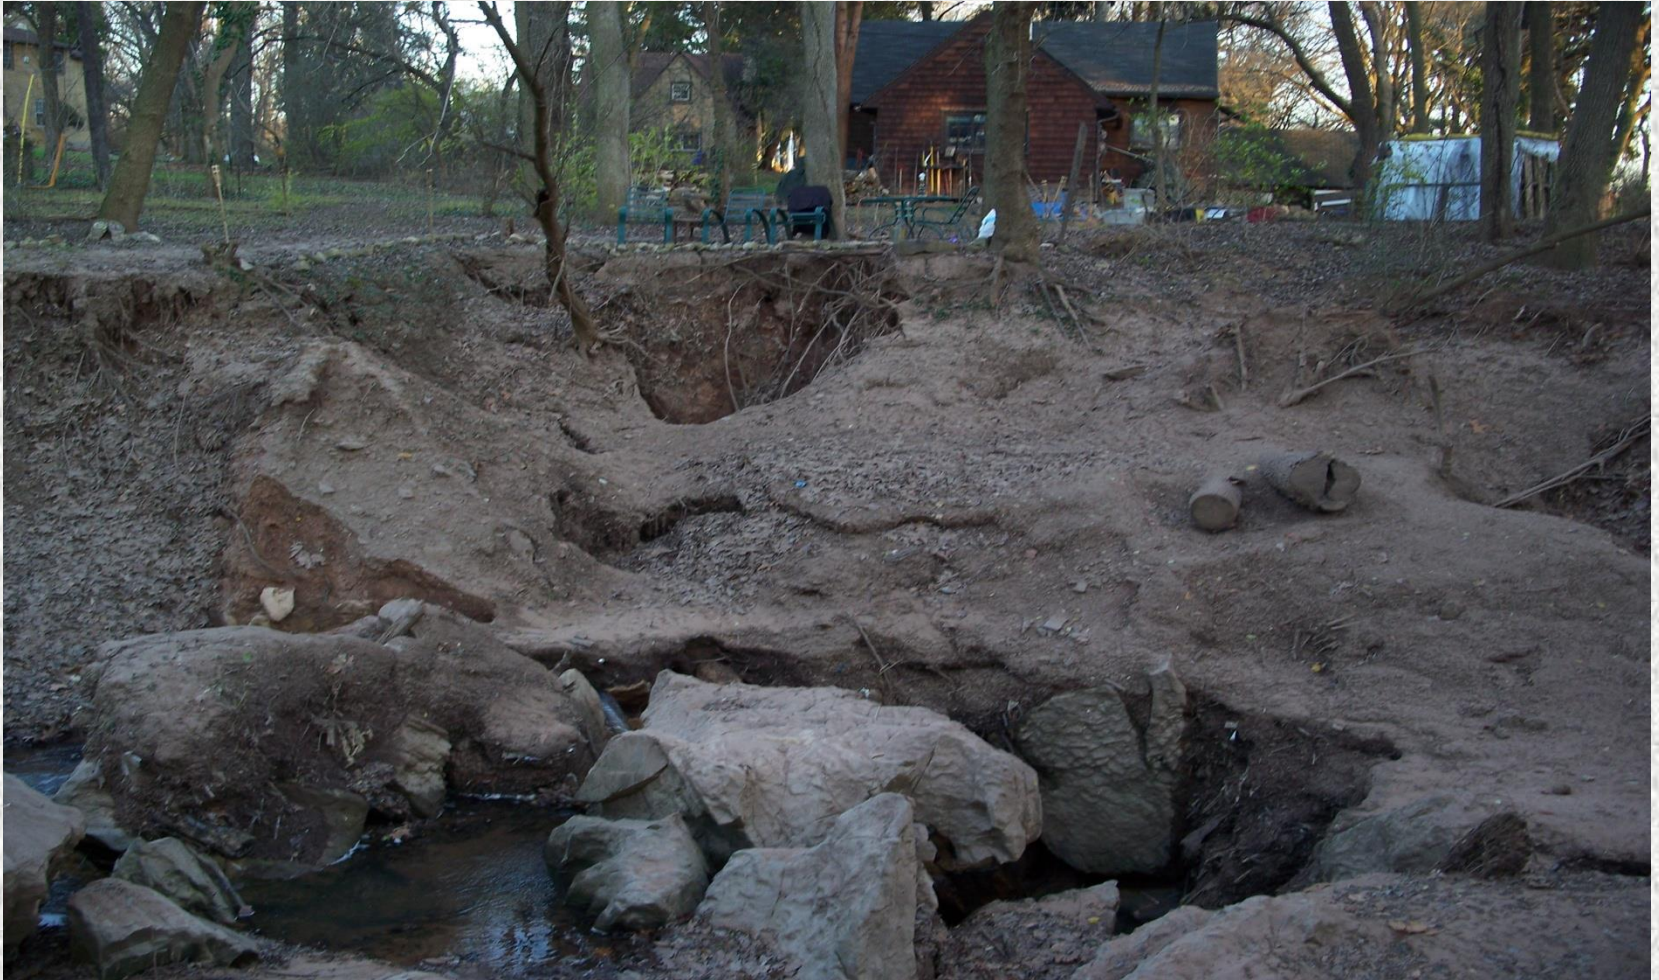
# Large sinkhole causing disappearing stream

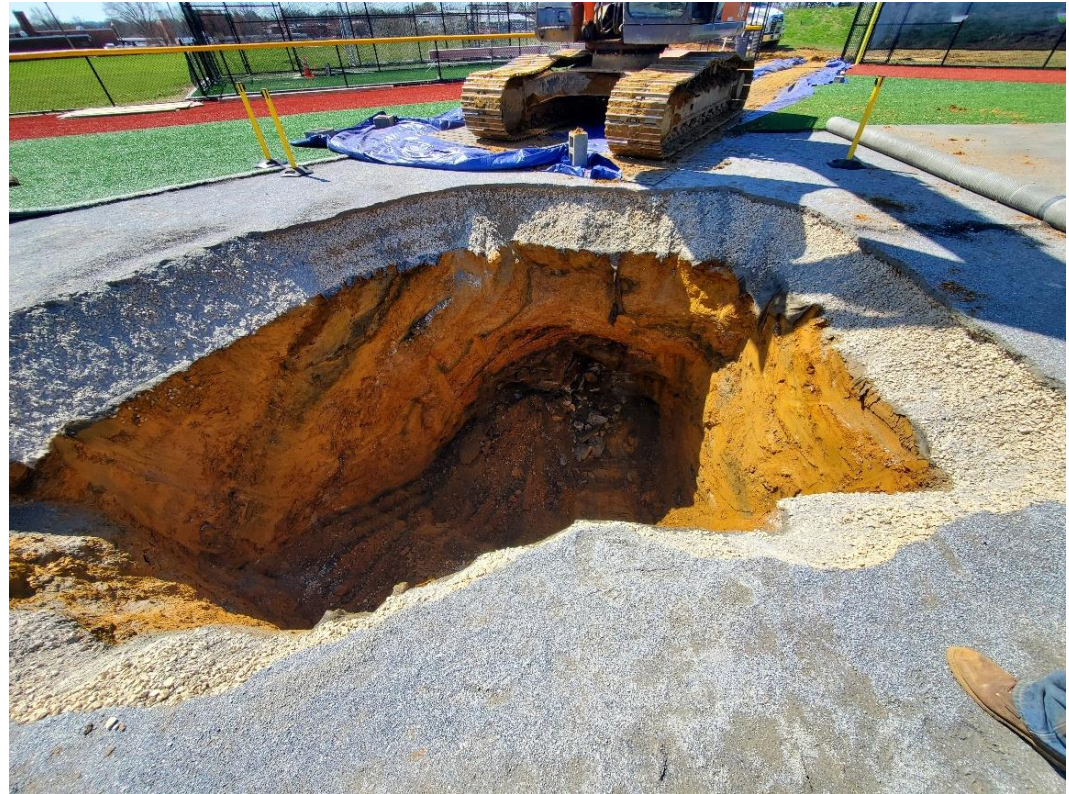
# Remediation: Inverted Filter Method: Excavation and Replacement Technique Recommended by Earth Engineering Inc.

Excavation of sinkhole conducted with large track-hoe to remove the excessively soft/loose soils from sinkhole.

Excavation was conducted to the bedrock surface on northwestern side of excavation.

Dense soils were encountered in remainder of excavation.

Overall approximate dimensions of the excavation were 22' x 17' x 12' to 14' (length x width x depth).

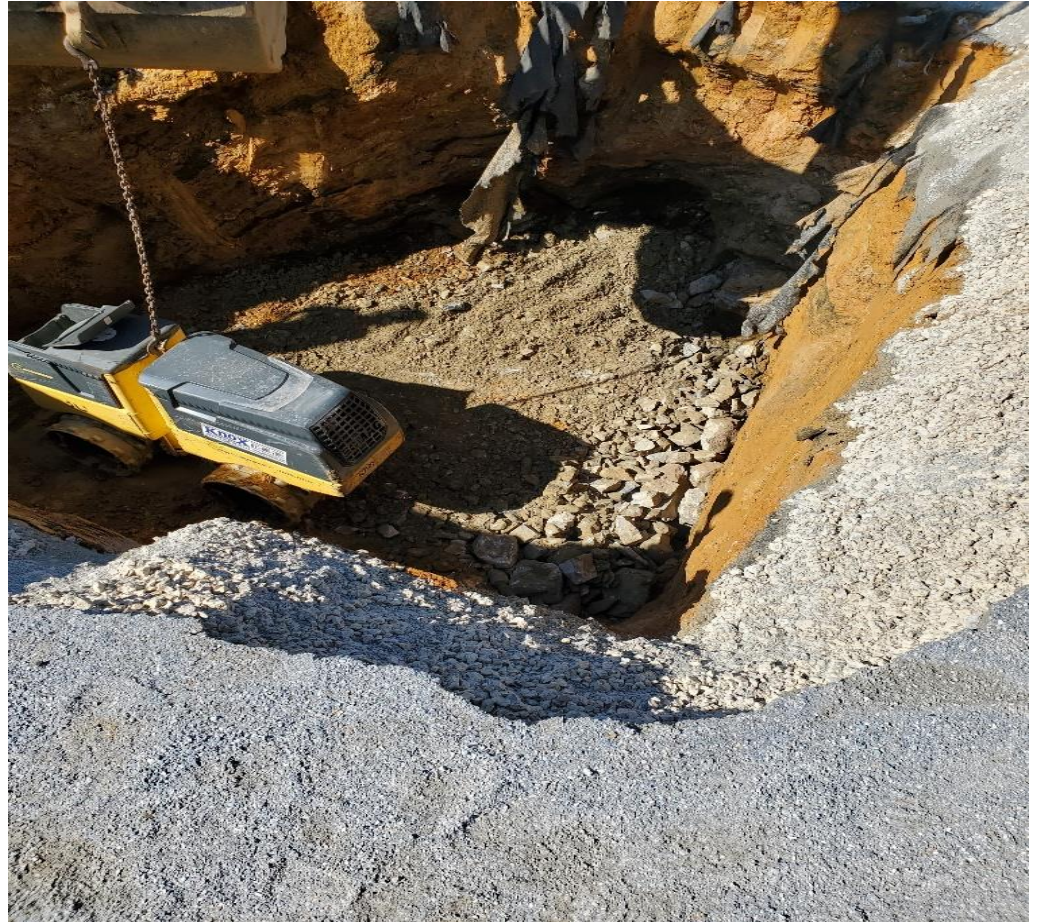
## Placement and Compaction of Shot Rock Layer

Compaction was performed to densify the layer of shot rock placed.

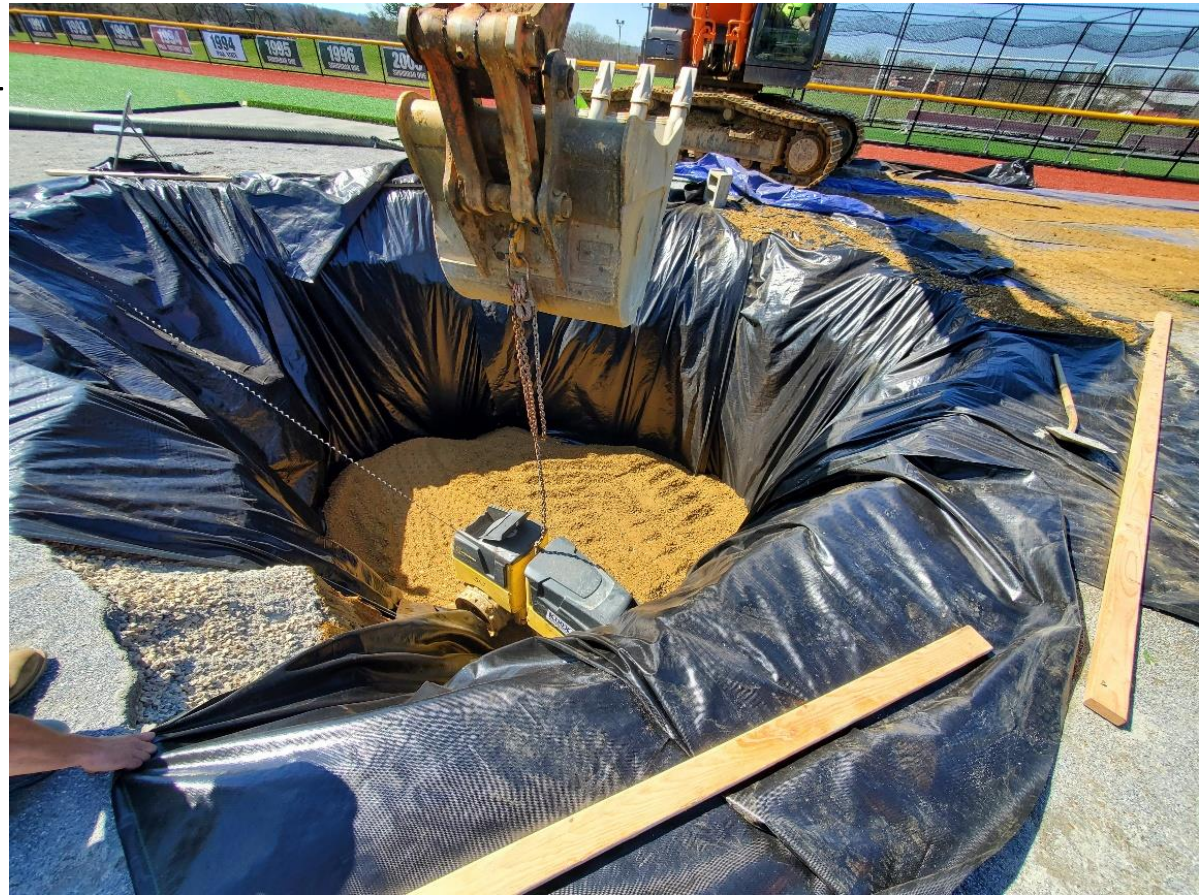
# Lining excavation with geotextile fabric and backfilling with PADOT 2A aggregate

The remaining sides and base of excavation were lined with a woven geotextile fabric and backfilled with 12" thick lifts of PADOT 2A aggregate. Each lift was compacted with the Rammex trench roller.

3 feet of aggregate was placed and compacted in the sinkhole excavation.

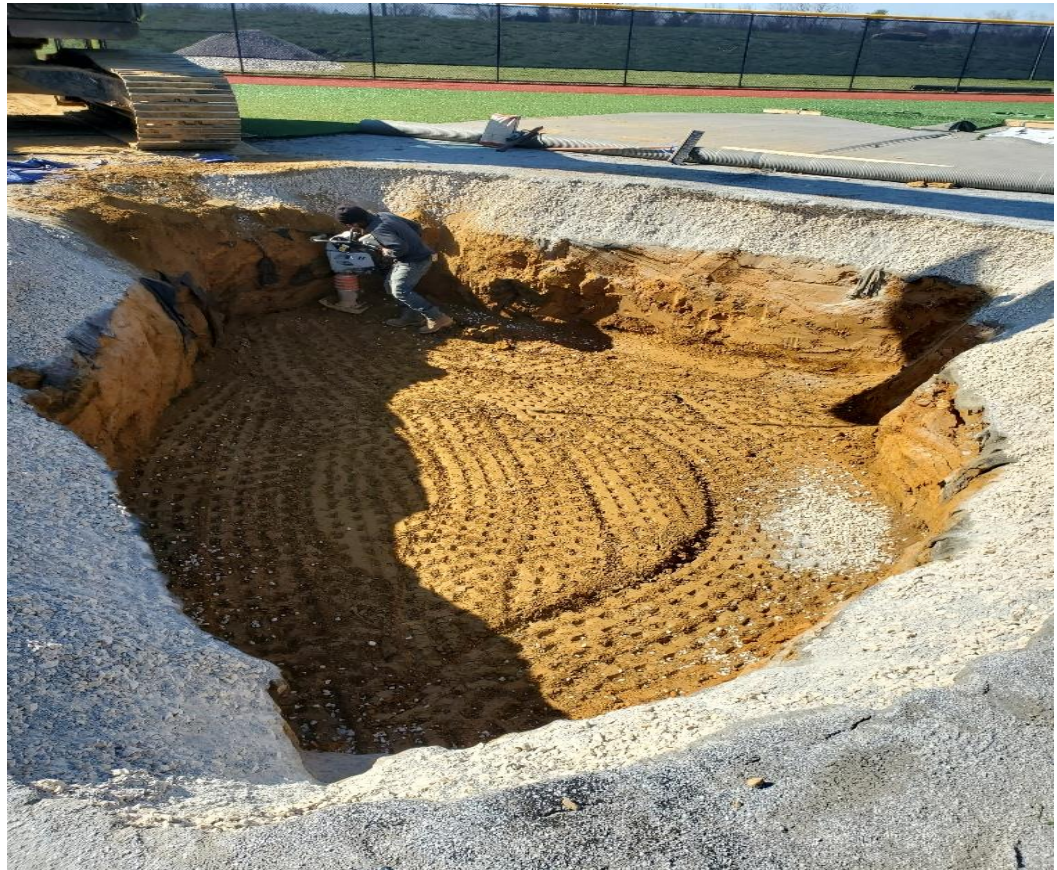
## Backfill and compaction with excavated soil

The remainder of excavation was backfilled with the excavated soils in multiple 12" lifts to the soil subgrade elevation.

Each lift was compacted with a combination of the Rammex trench roller and a Jumping Jack Tamper.

The Jumping Jack tamper was performed around the perimeter of the excavation to seal the edges of each lift.

During visual inspection, each lift was observed to be firm, stable and well compacted.

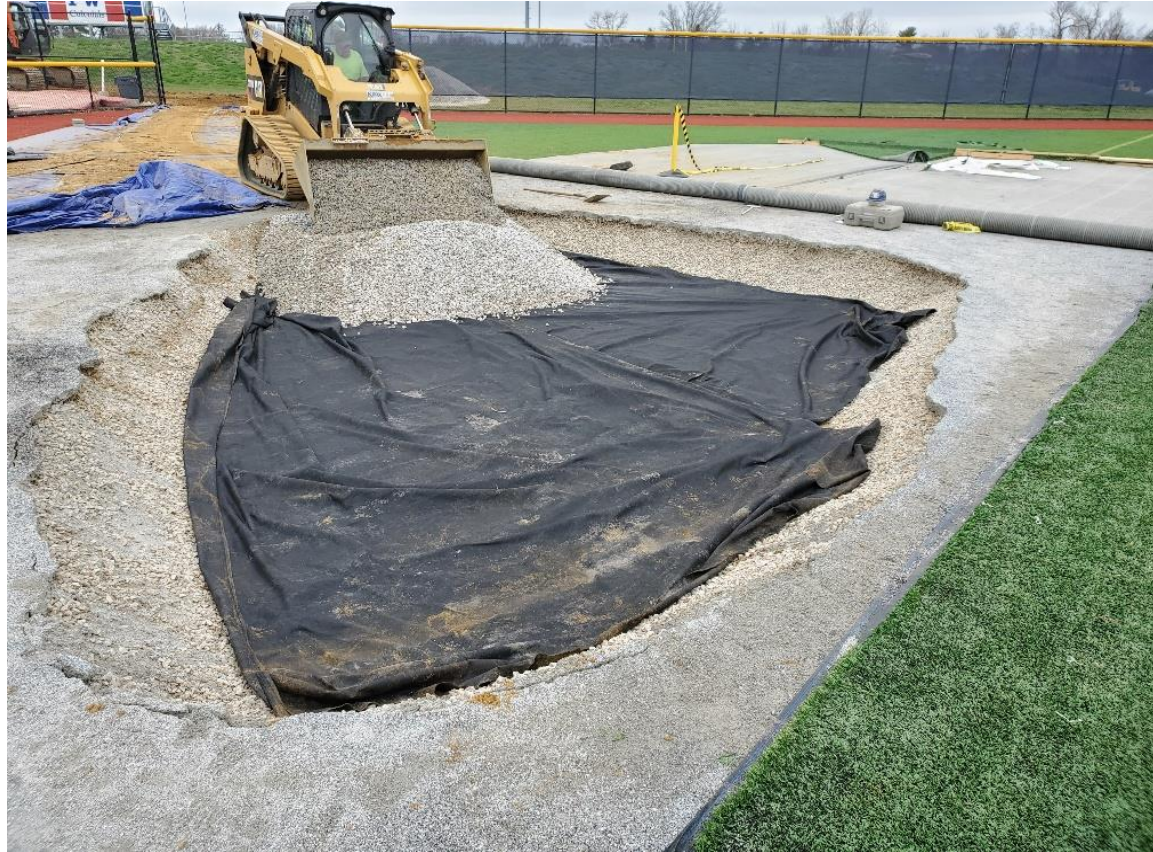
## Contractor placing subbase stone

The contractor replaced the PADOT 2B subbase stone layer to match the surrounding stone layer.

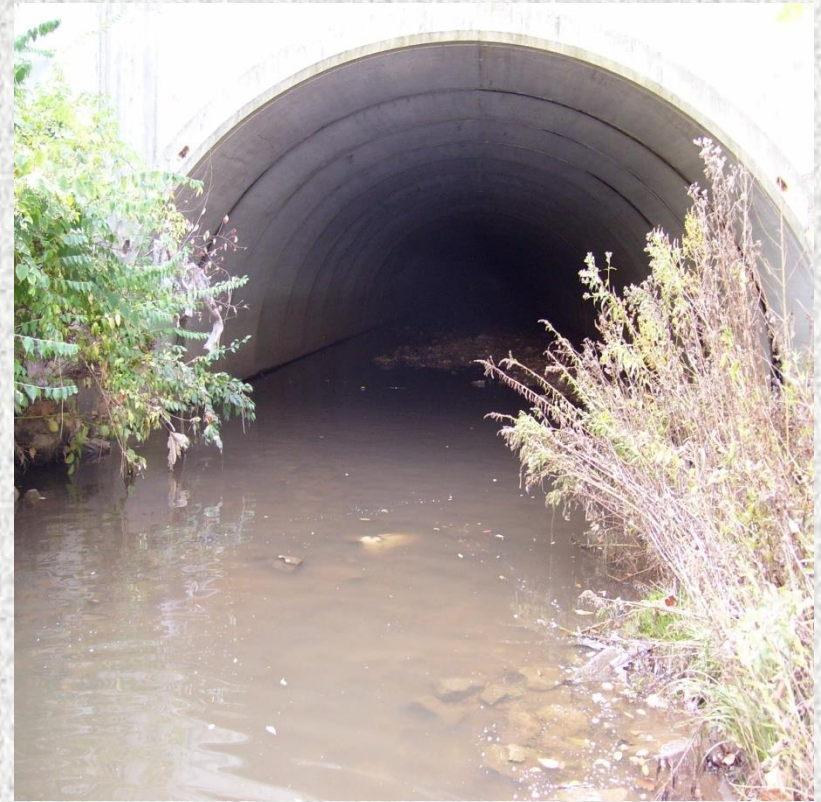
- Culvert measures approx 30' wide by 15' in height by 1500 feet in length
- Required a Natural Stream bottom throughout structure
- Several Pipe Penetration Locations Inside causing scour and poor grading

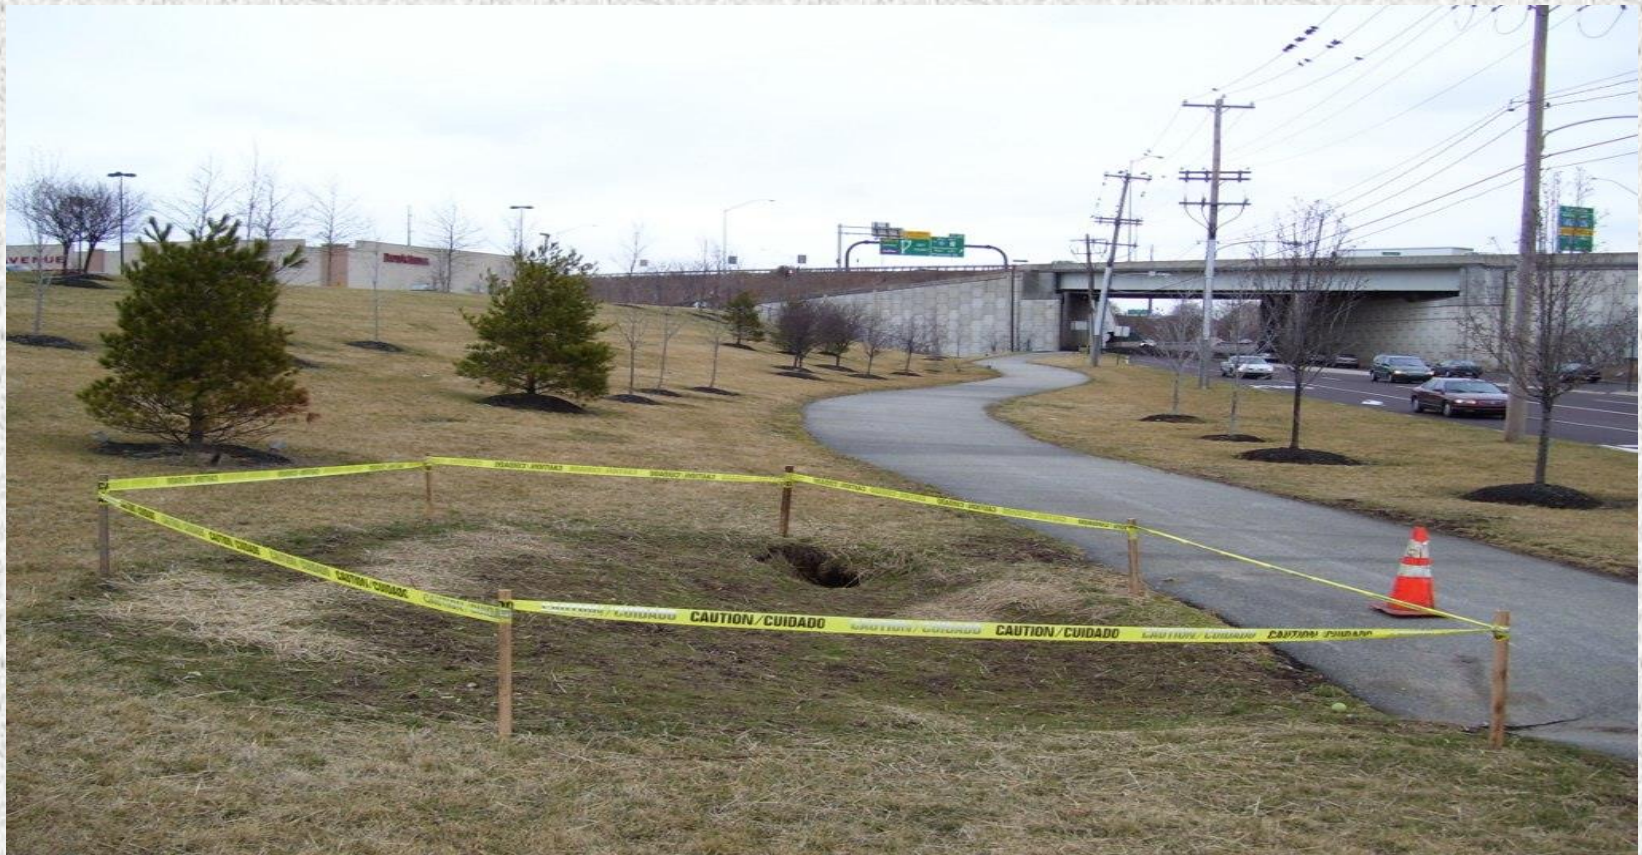
# First Sinkhole - March

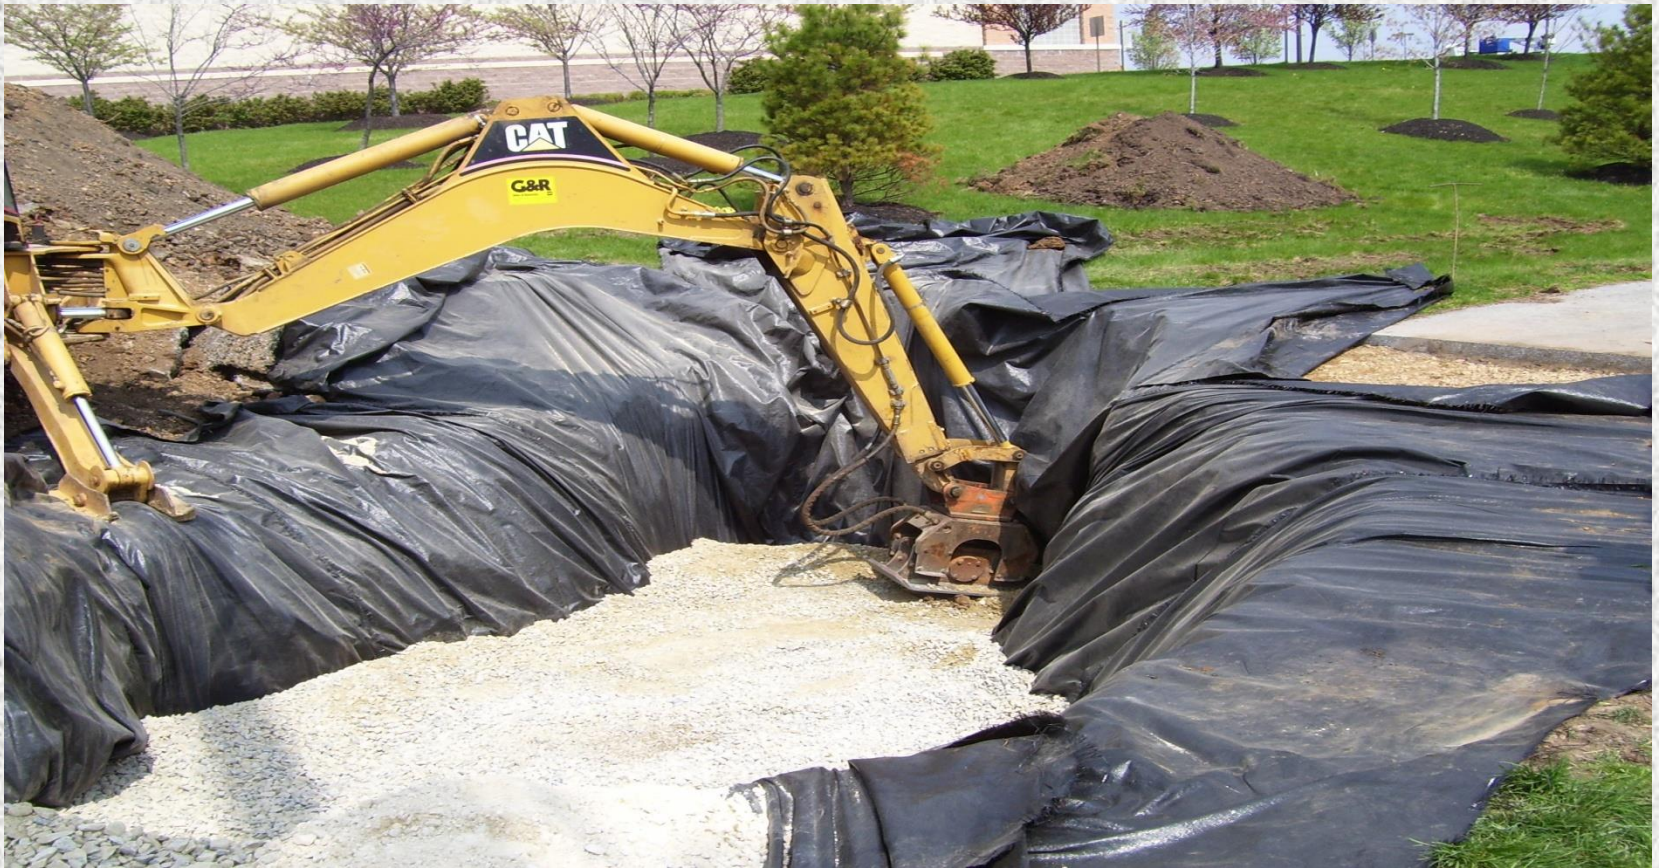
# Excavation and Replacement method utilized to stabilize sinkhole

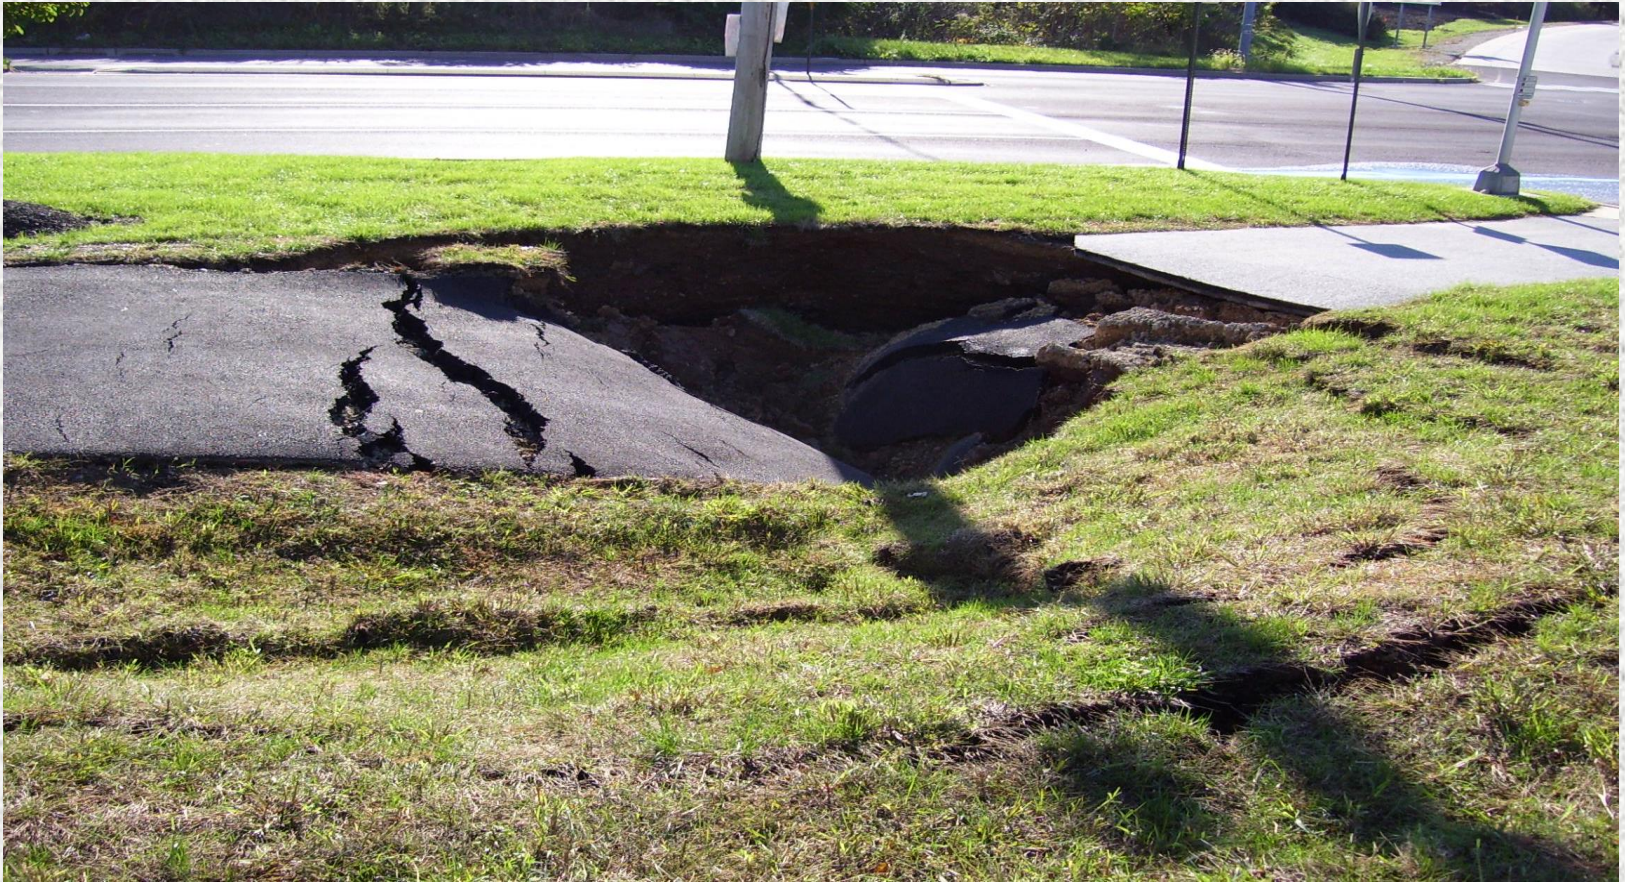
## 2<sup>nd</sup> Sinkhole – November

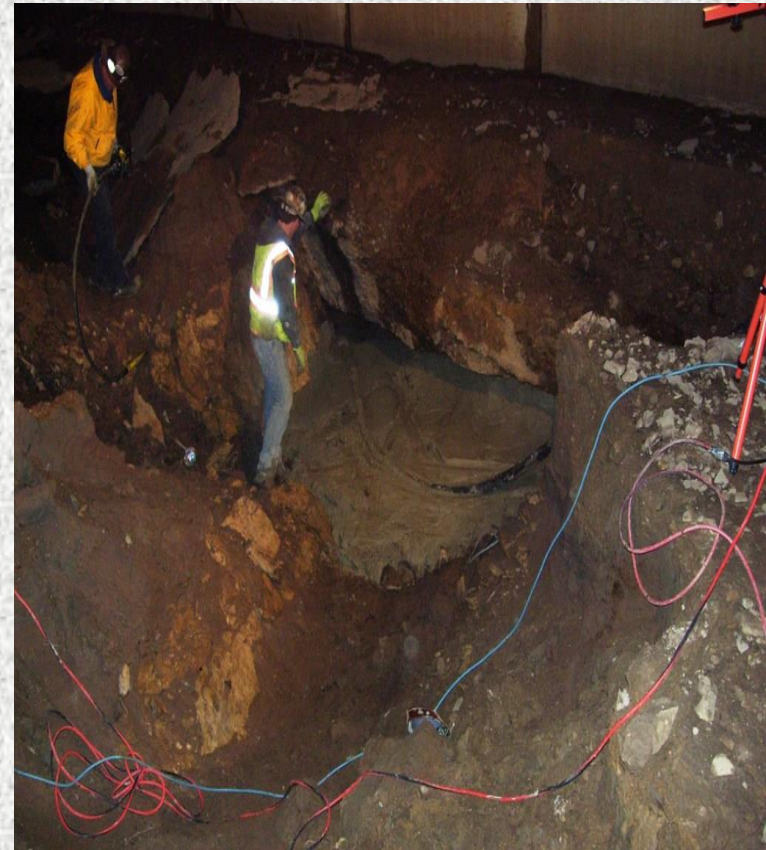
# Sinkhole Re-Emerges – two years later

- Very large Sinkhole discovered inside culvert
- A portion of the culvert foundations undermined by sinkhole activity
- Open void backfilled with grout to protect foundations

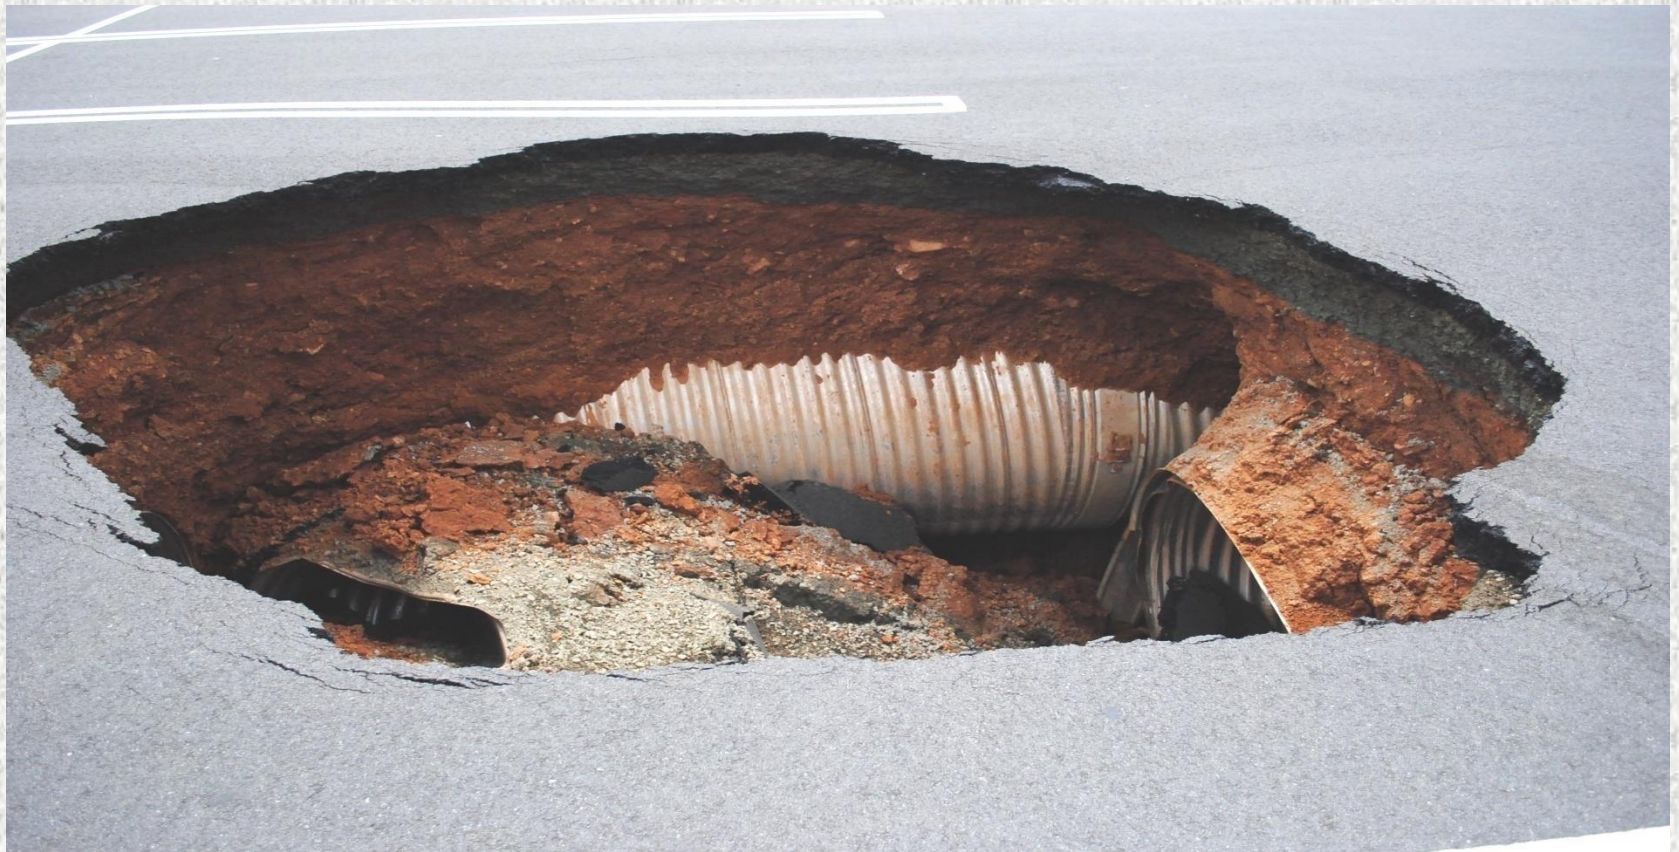
# Site #3 – Sinkhole Below Underground Detention Basin – Initially 16' in diameter by 15' in depth

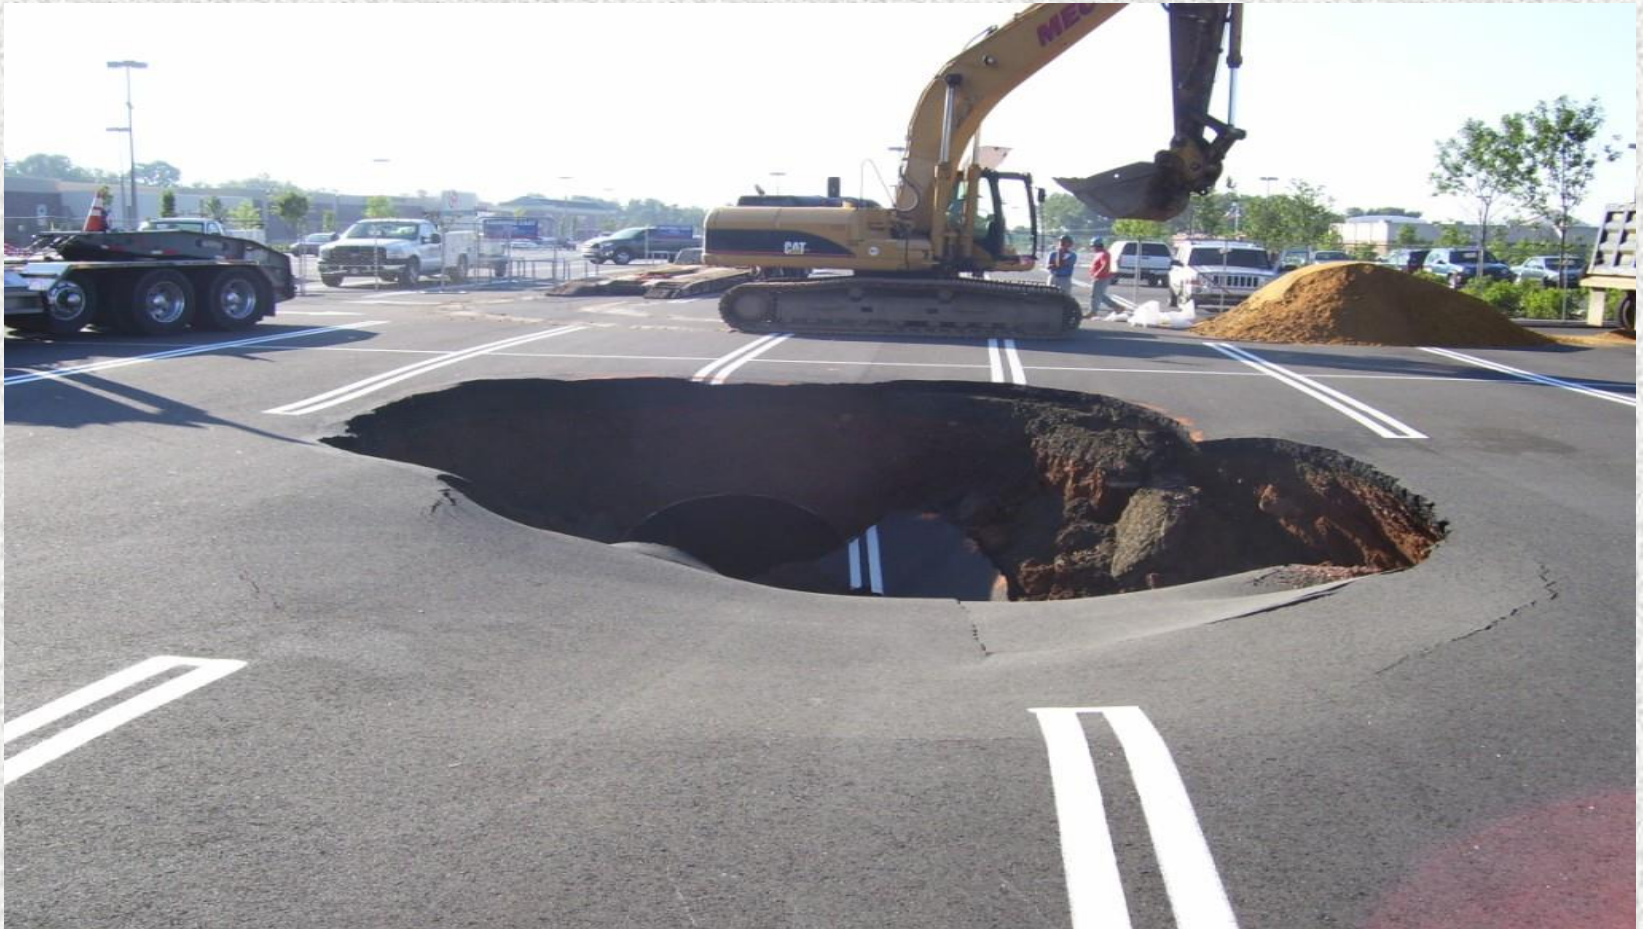
Large Rain Event caused sinkhole to expand to 40' in diameter by 15' in depth

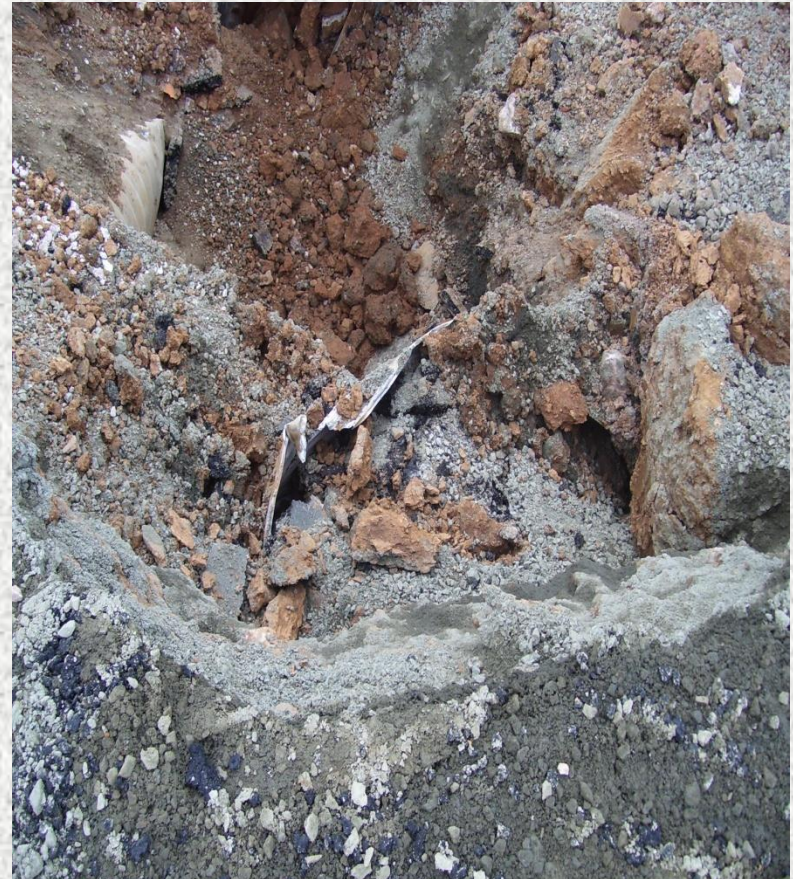
- Leaking connection between connecting pipes suspected as cause of sinkhole
- During the excavation process, a section of pipe was vertical in sinkhole

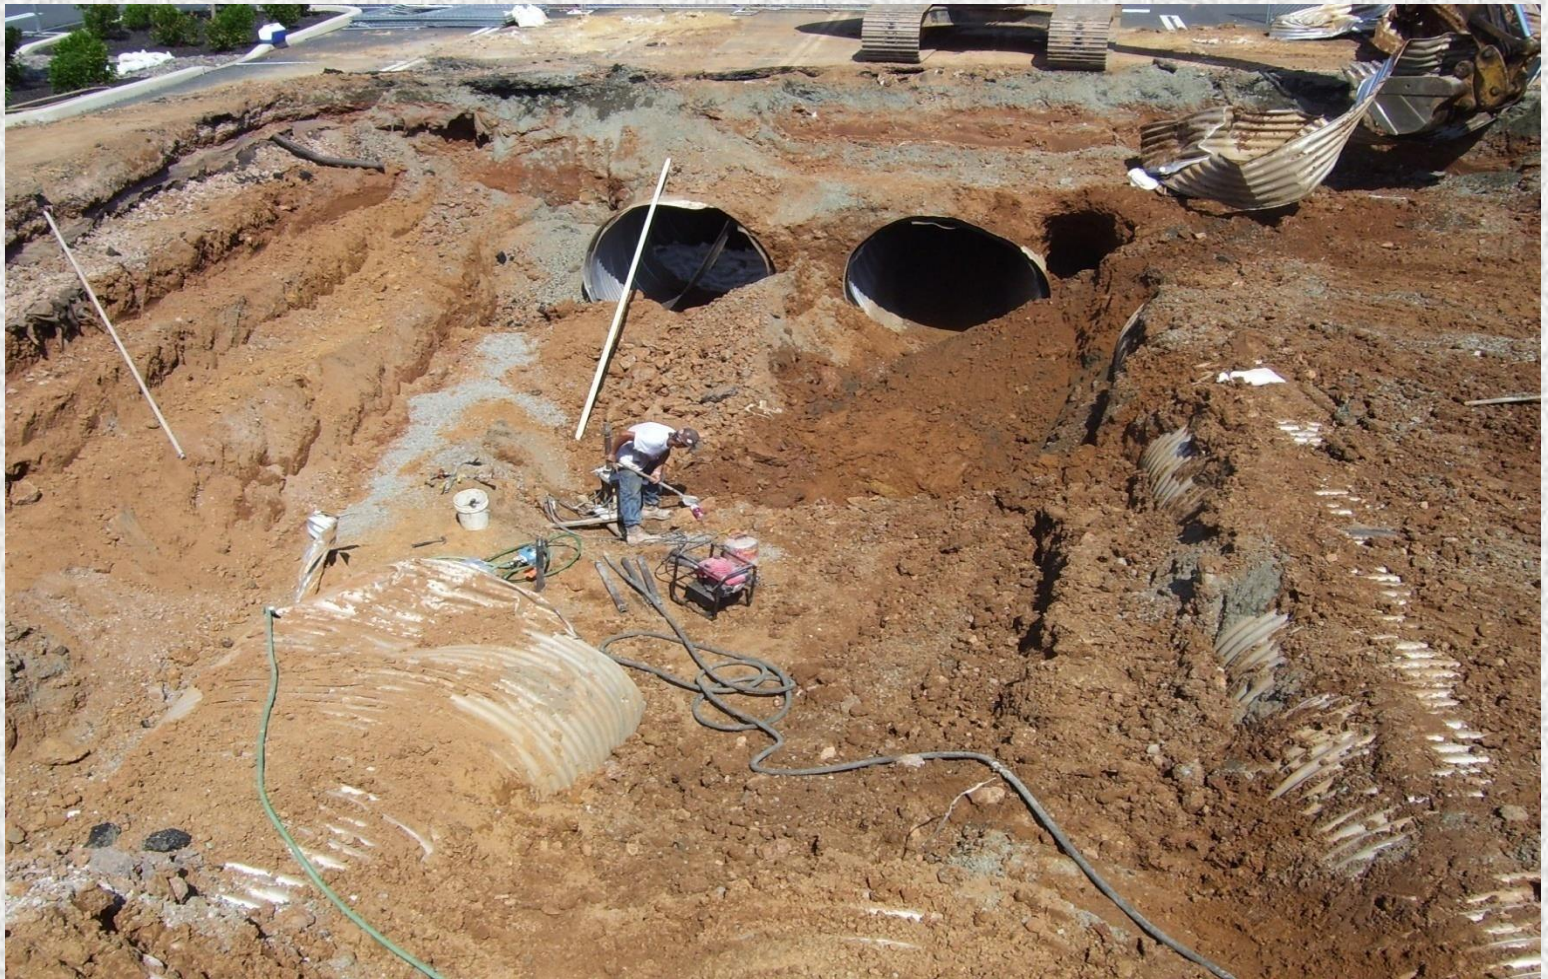
# Grouting conducted in a grid pattern in open excavation

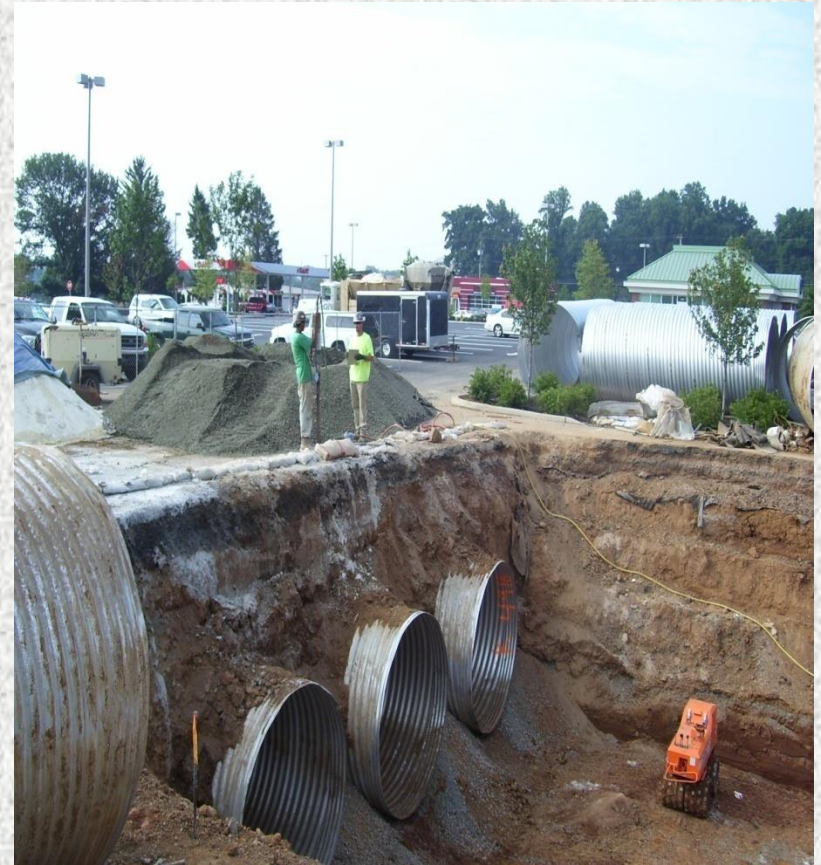
- Grouting also conducted outside of excavation to minimize potential growth
- A combination of Permeation grouting and low mobility grouting used to effectively stabilize sinkhole
- This method proved to fill in voids and fractures in the bedrock and overburden soils

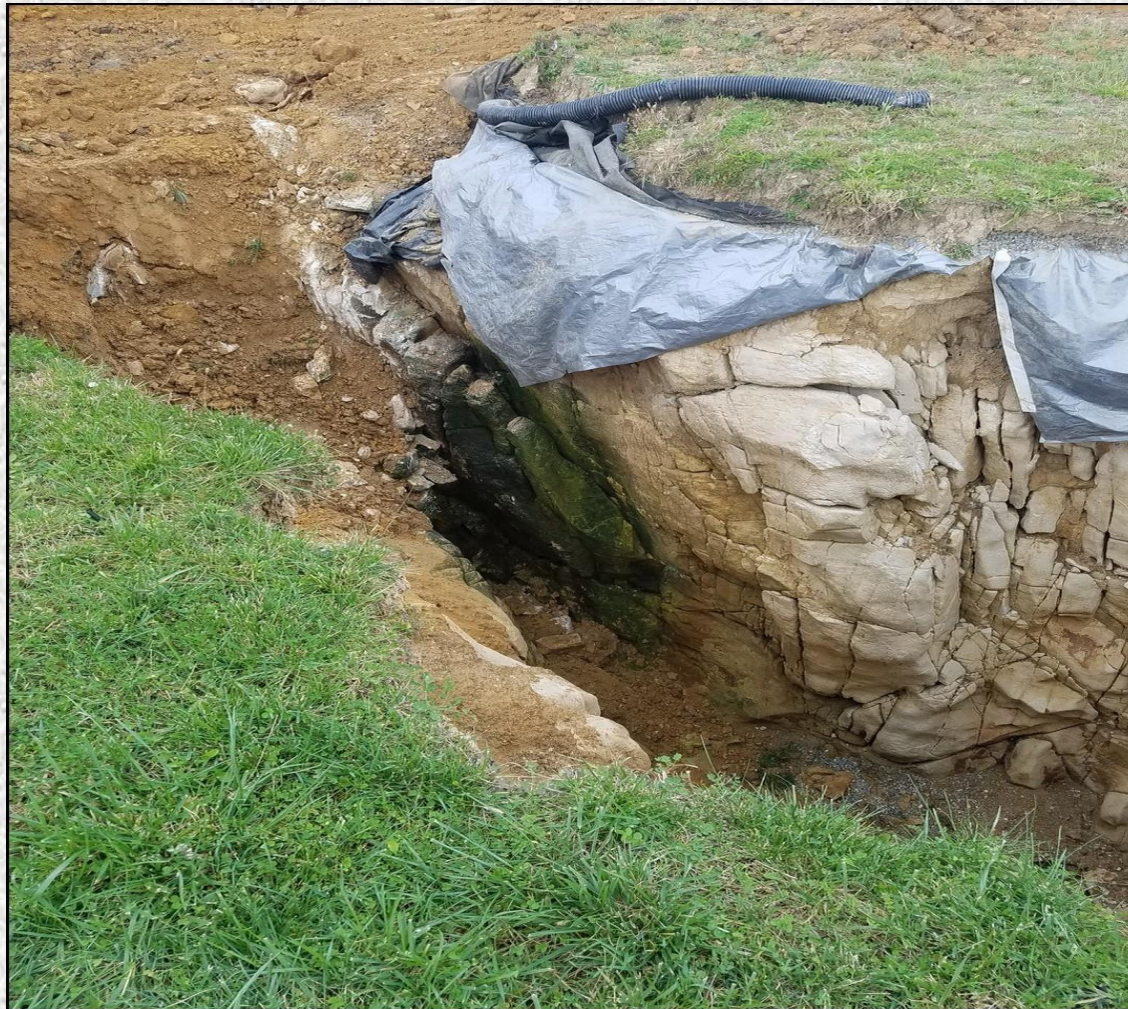
## **Limited Excavation Performed to further expose the bedrock**

Overall Sinkhole measured 35 feet in diameter by 30 feet in depth.

“Liner” only installed at bottom  
of basin and not up sides

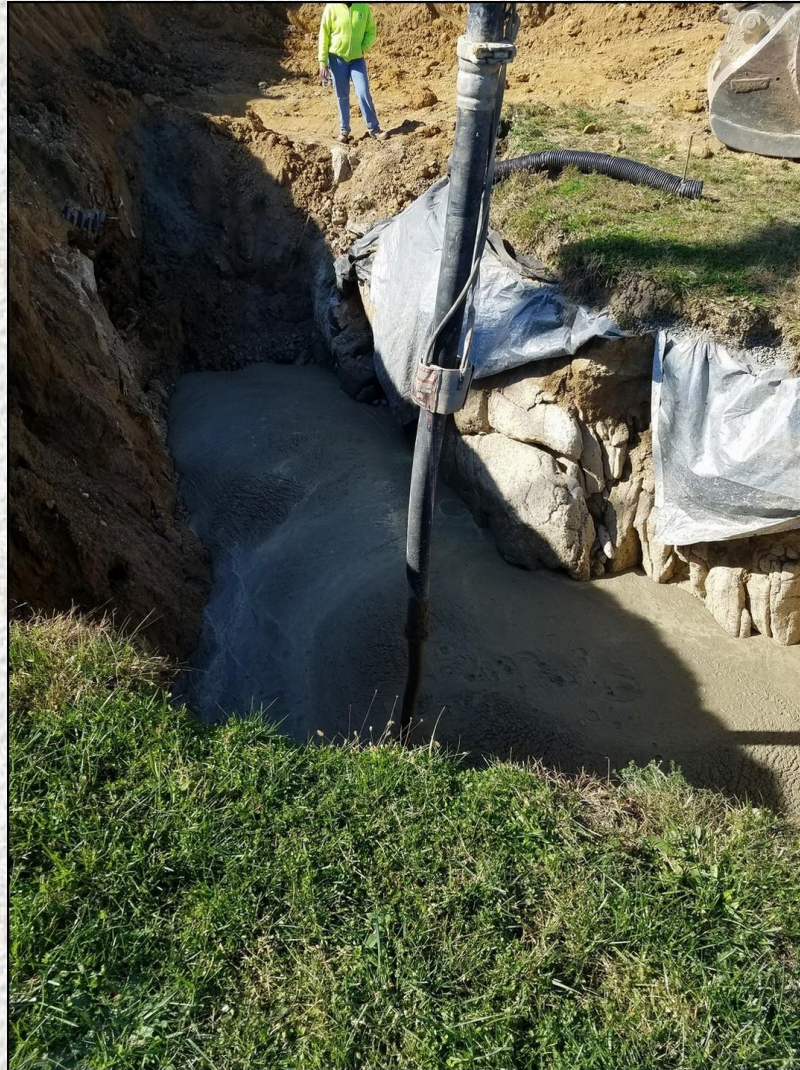
Flowable fill placed to slightly  
above the top of rock surface

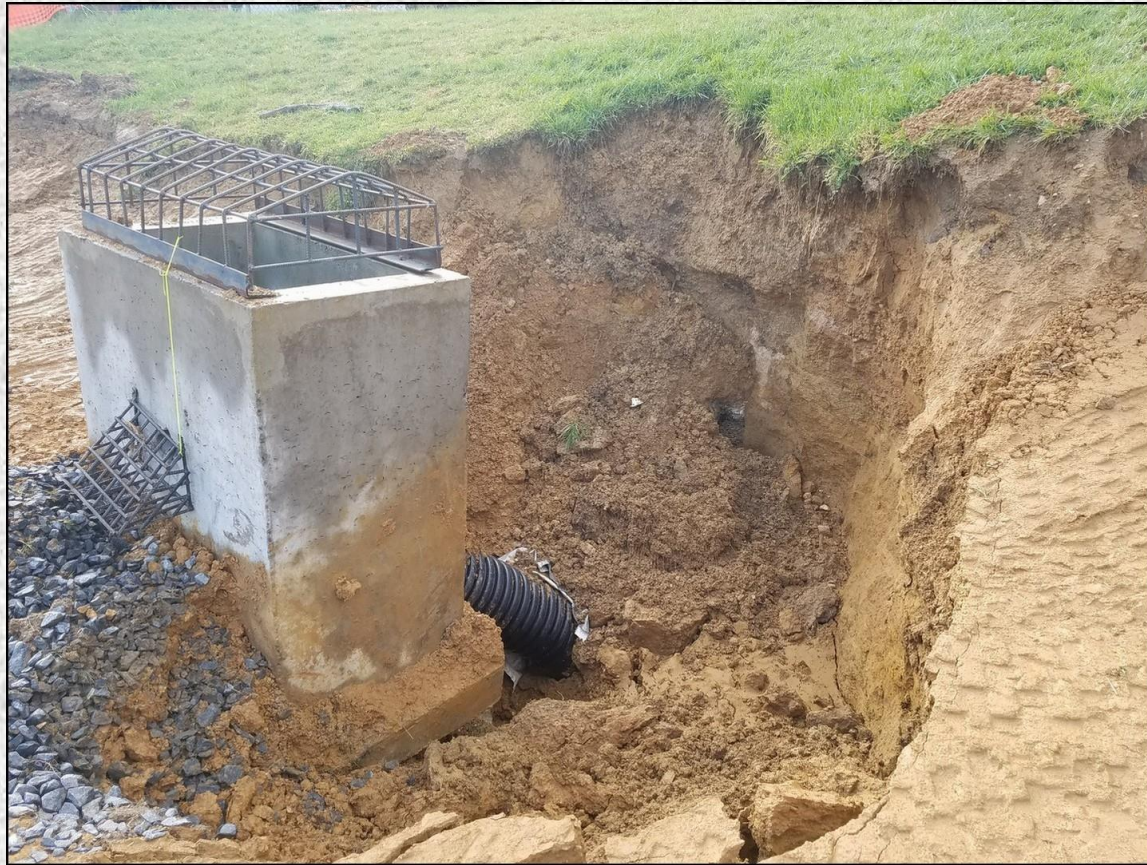
# New sinkhole forms after overflow structure installed
