# Managing a Project With Karst Geology

Chester County Engineers – Fall Conference 2021

**EARTH  
ENGINEERING  
INCORPORATED**

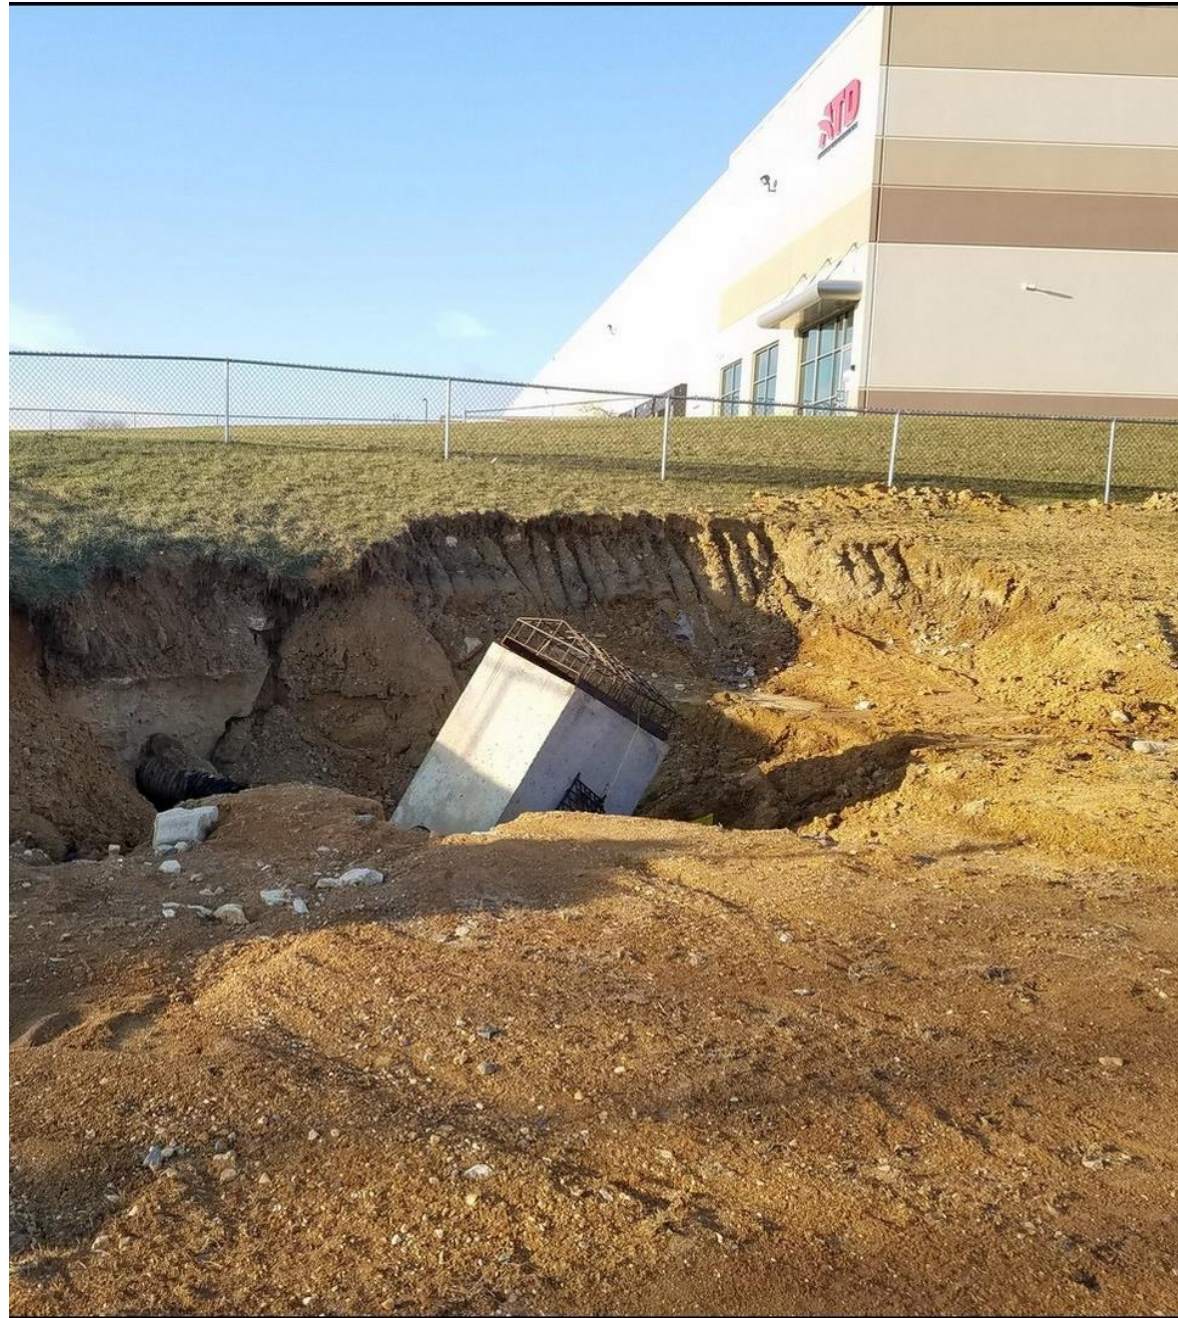
Excavation  
method used  
to stabilize  
new  
sinkhole

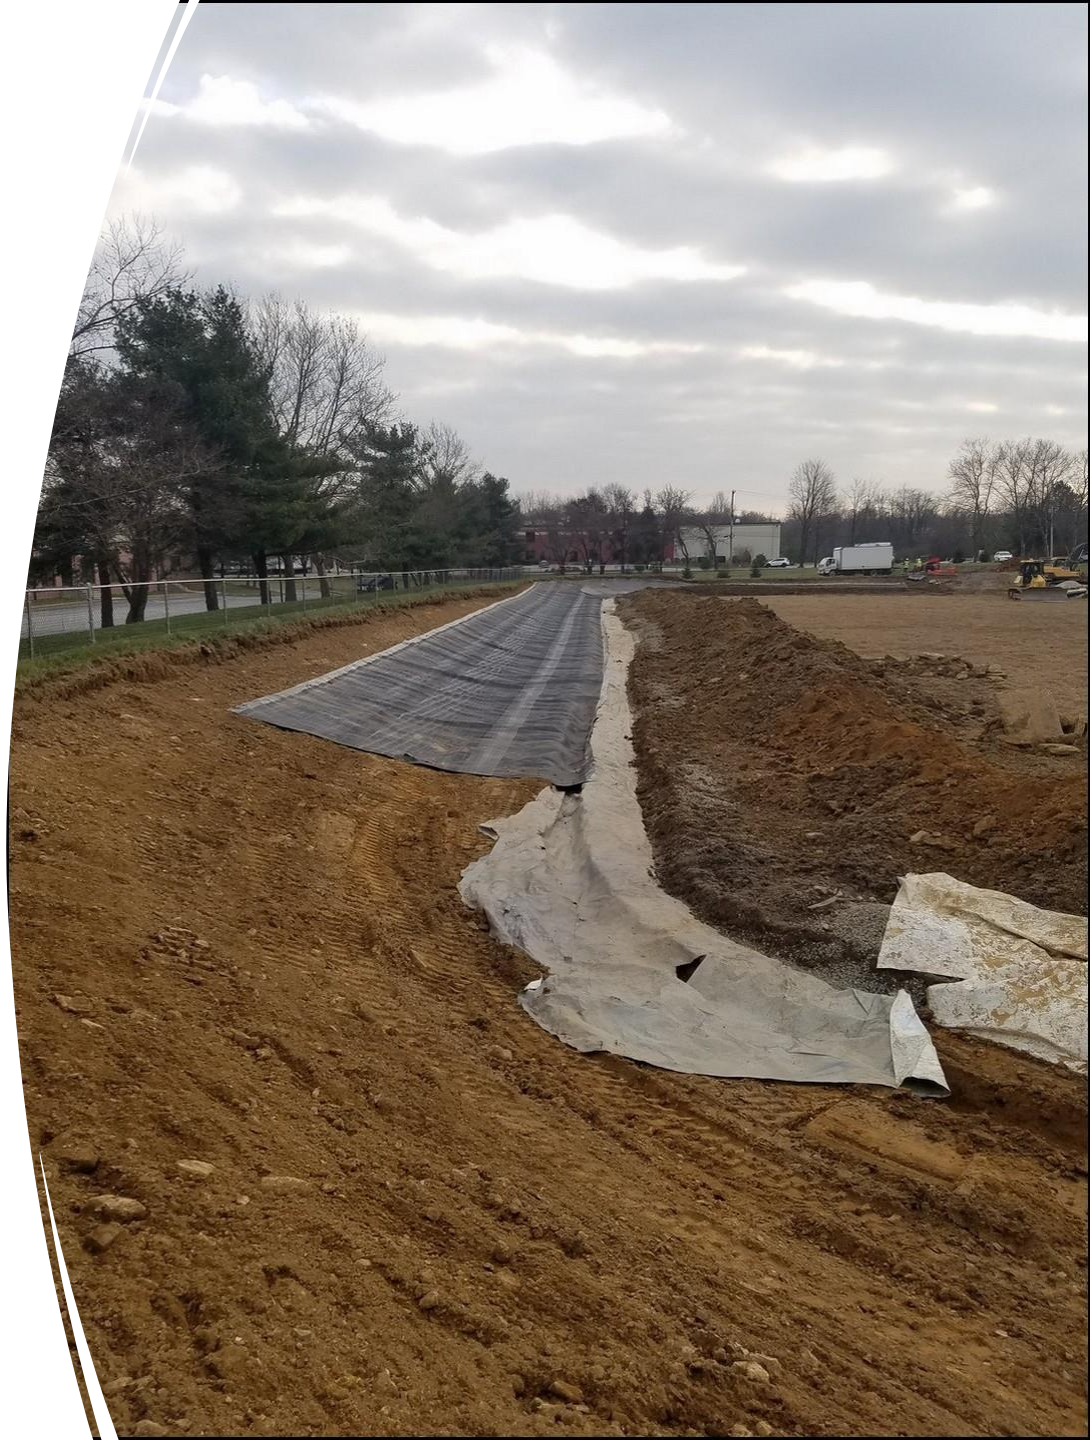
New liner  
installed on  
basin  
embankment

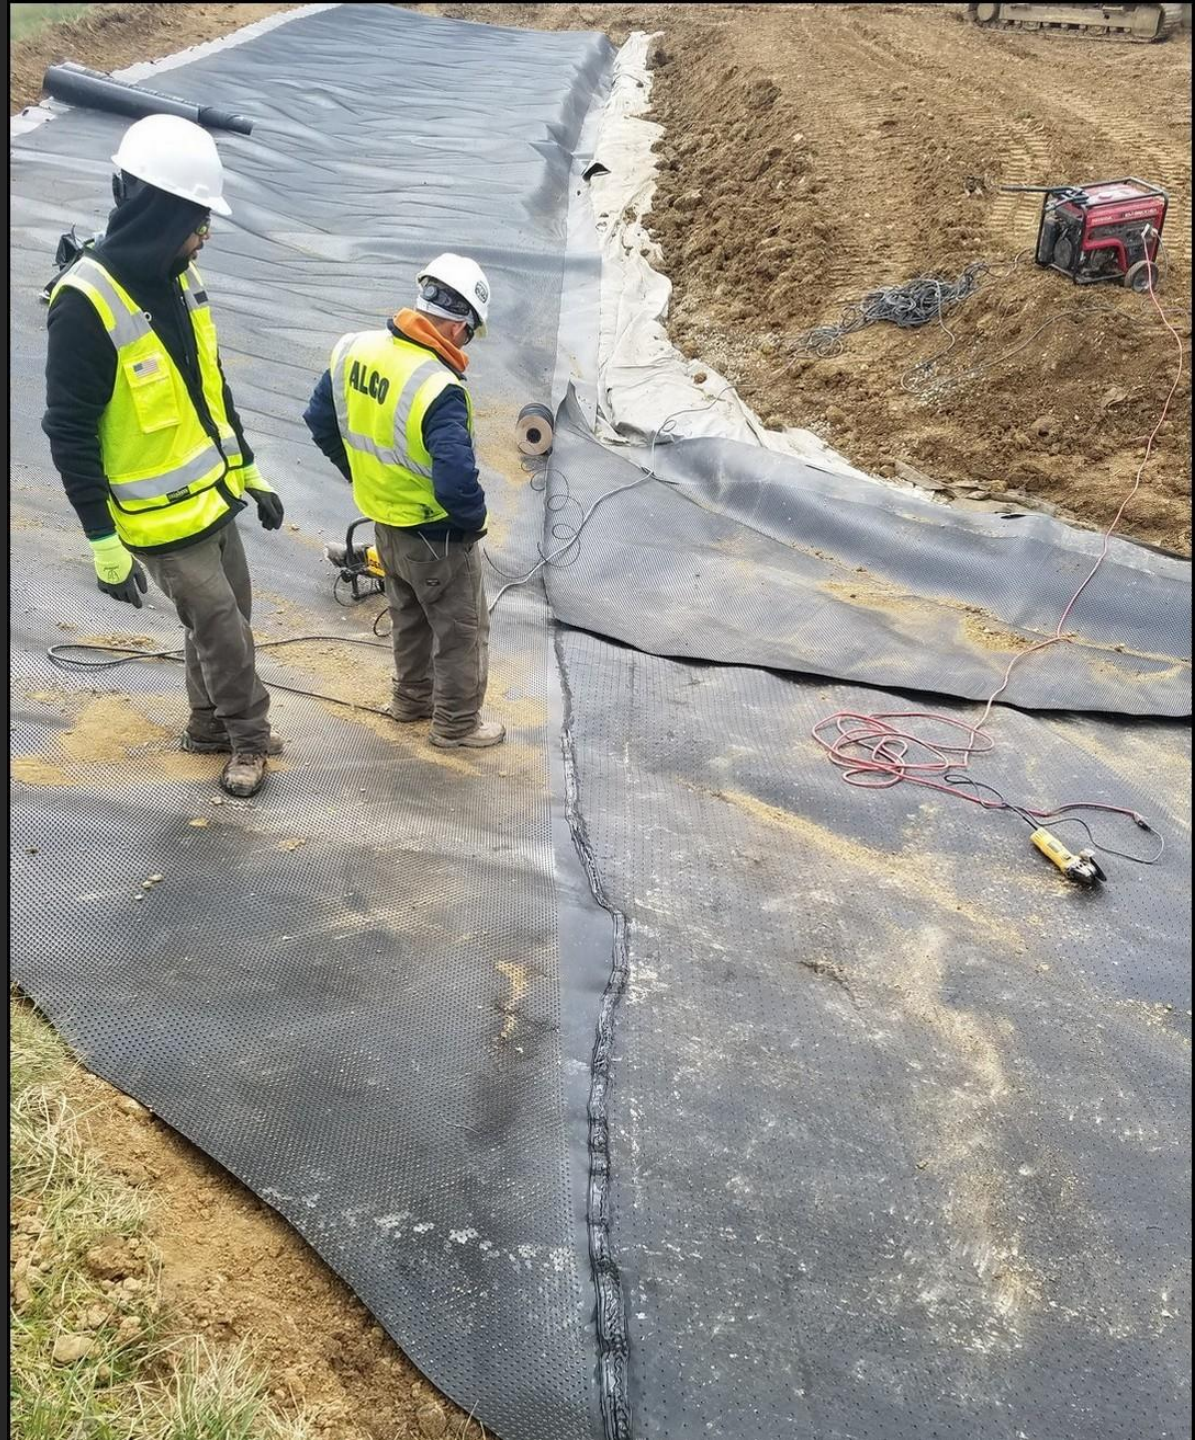
Liner  
installed by  
qualified  
contractor.  
Seams of new  
liner properly  
welded

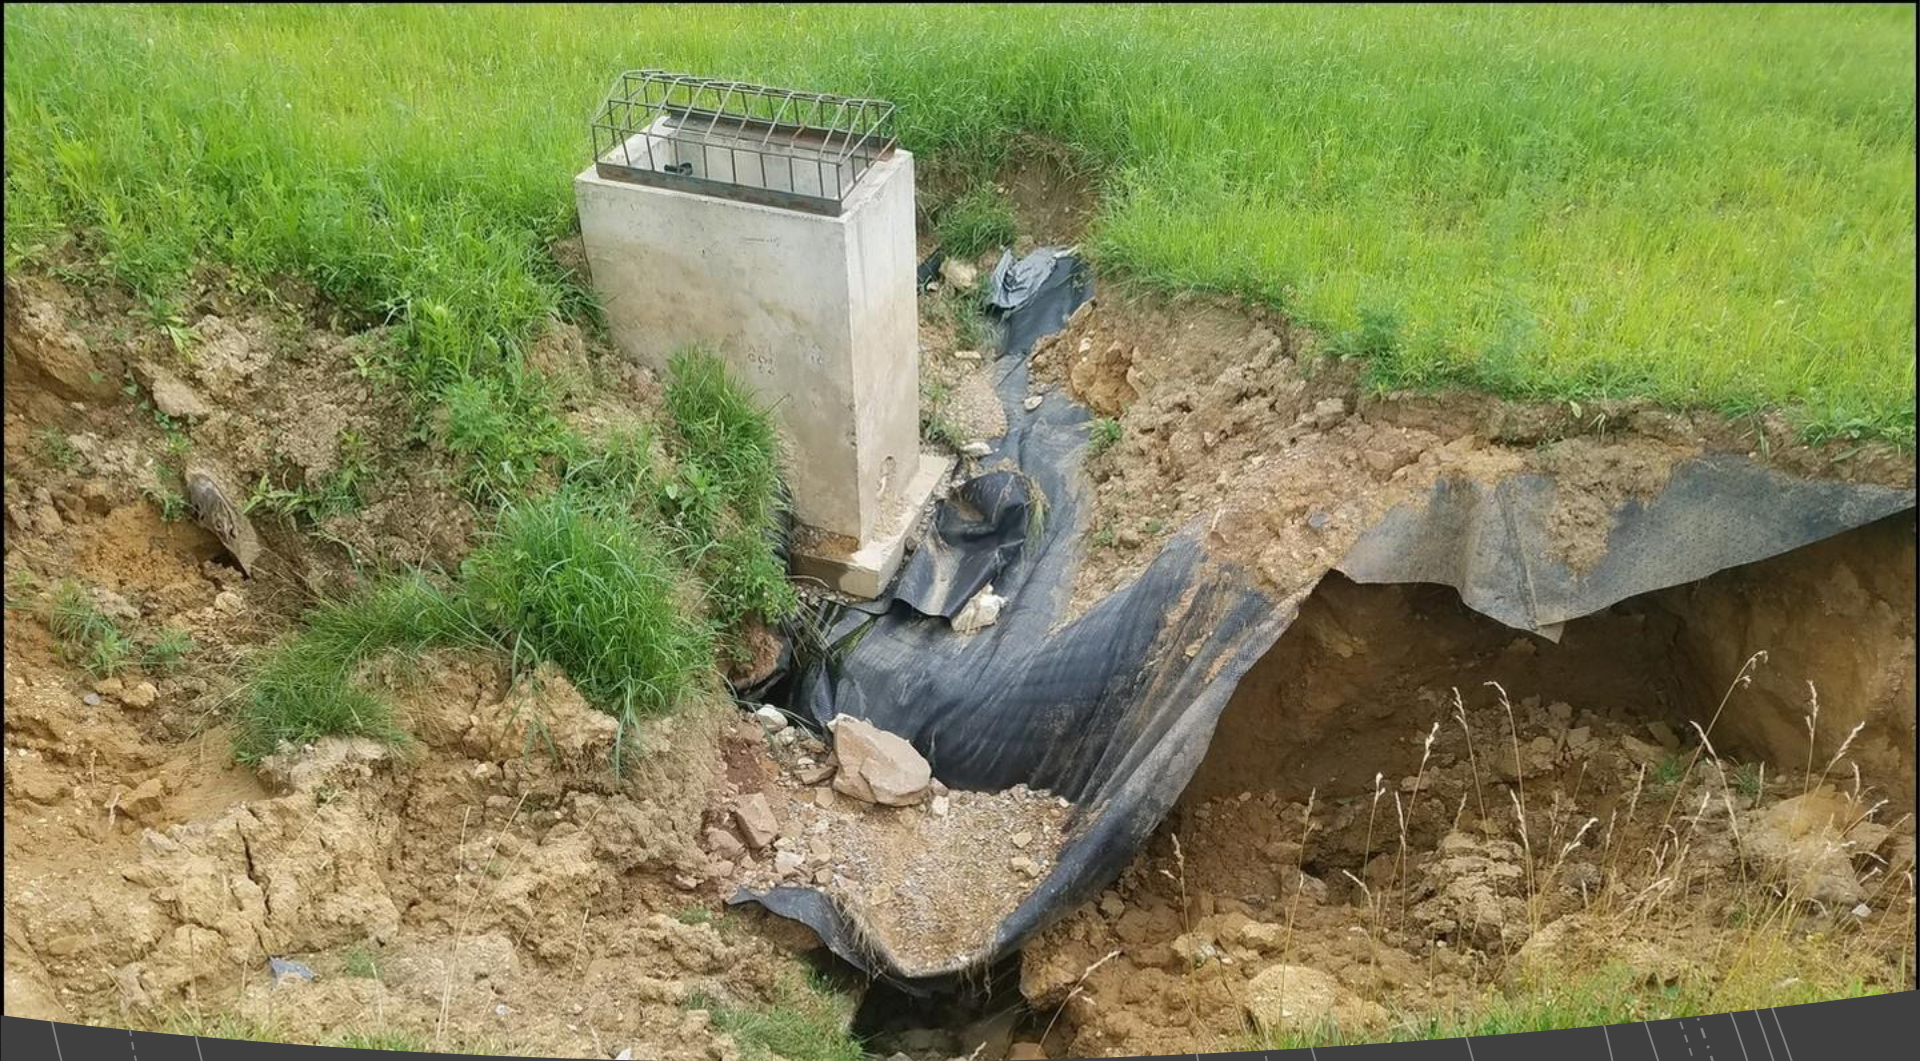
3<sup>rd</sup> sinkhole forms a few  
months later...

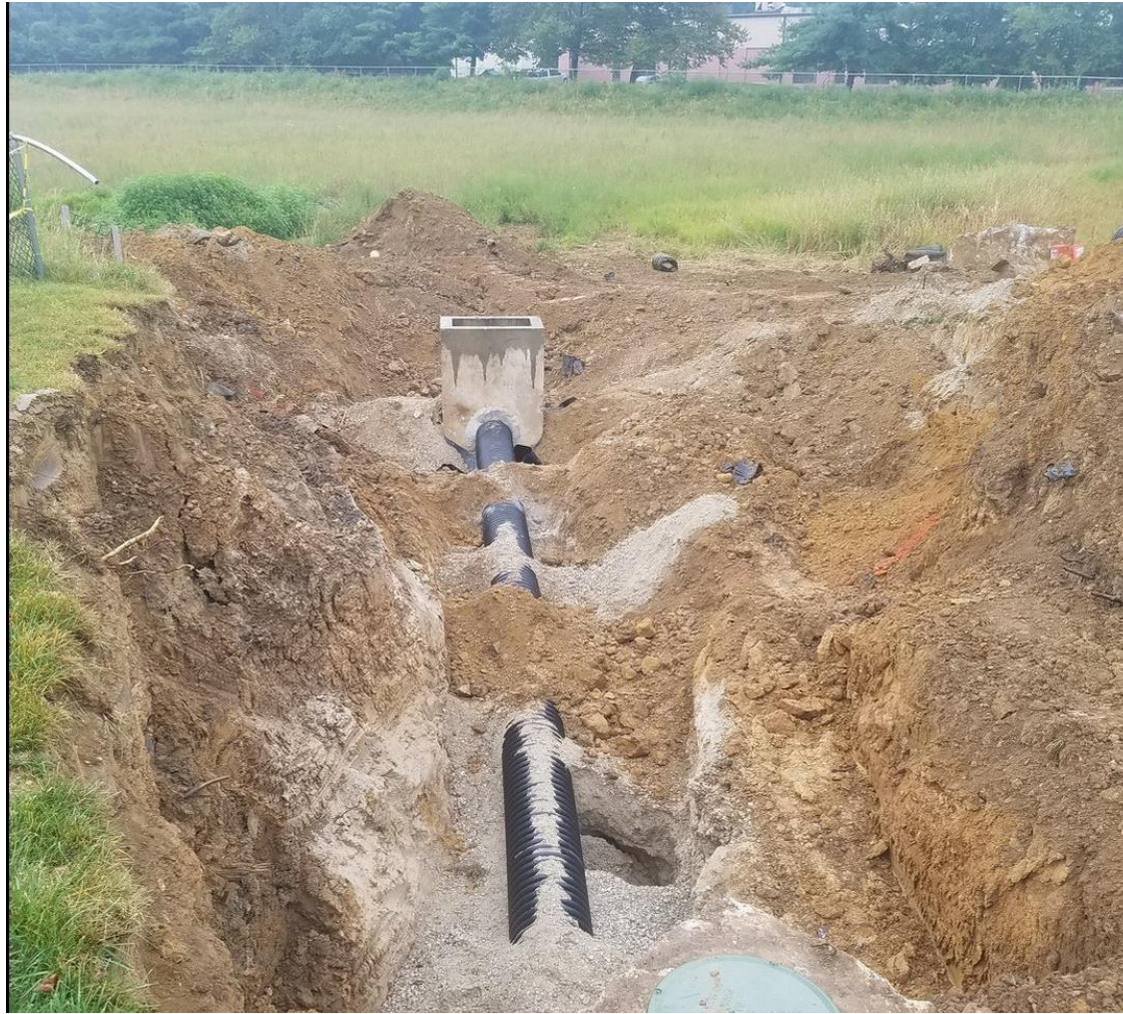
And grows..

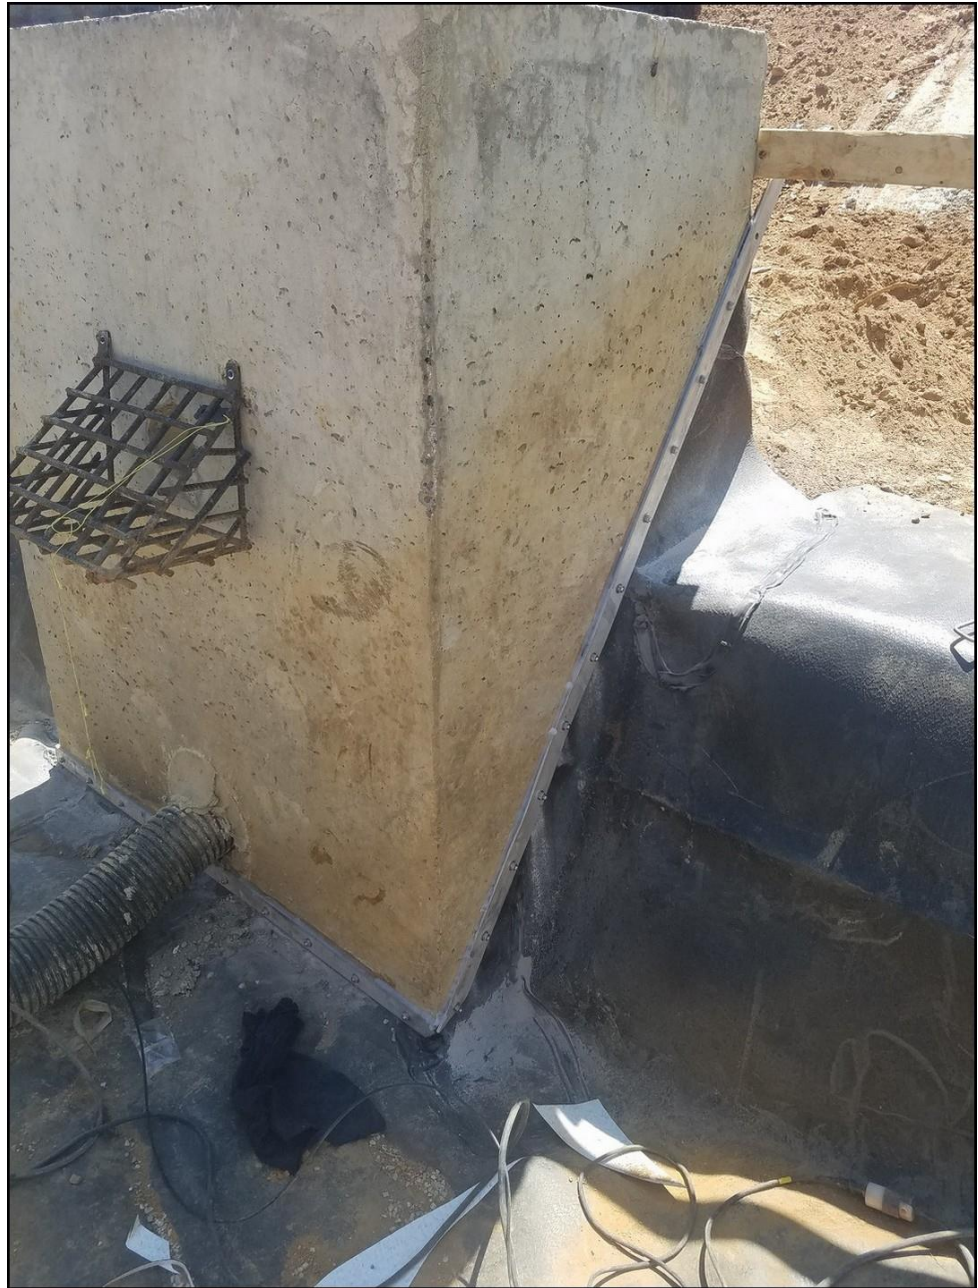
High  
mobility  
grout  
injected  
under  
pressure to  
seal voids at  
soil/bedrock  
interface

Batton strips  
used to create  
watertight  
seal between  
overflow and  
liner

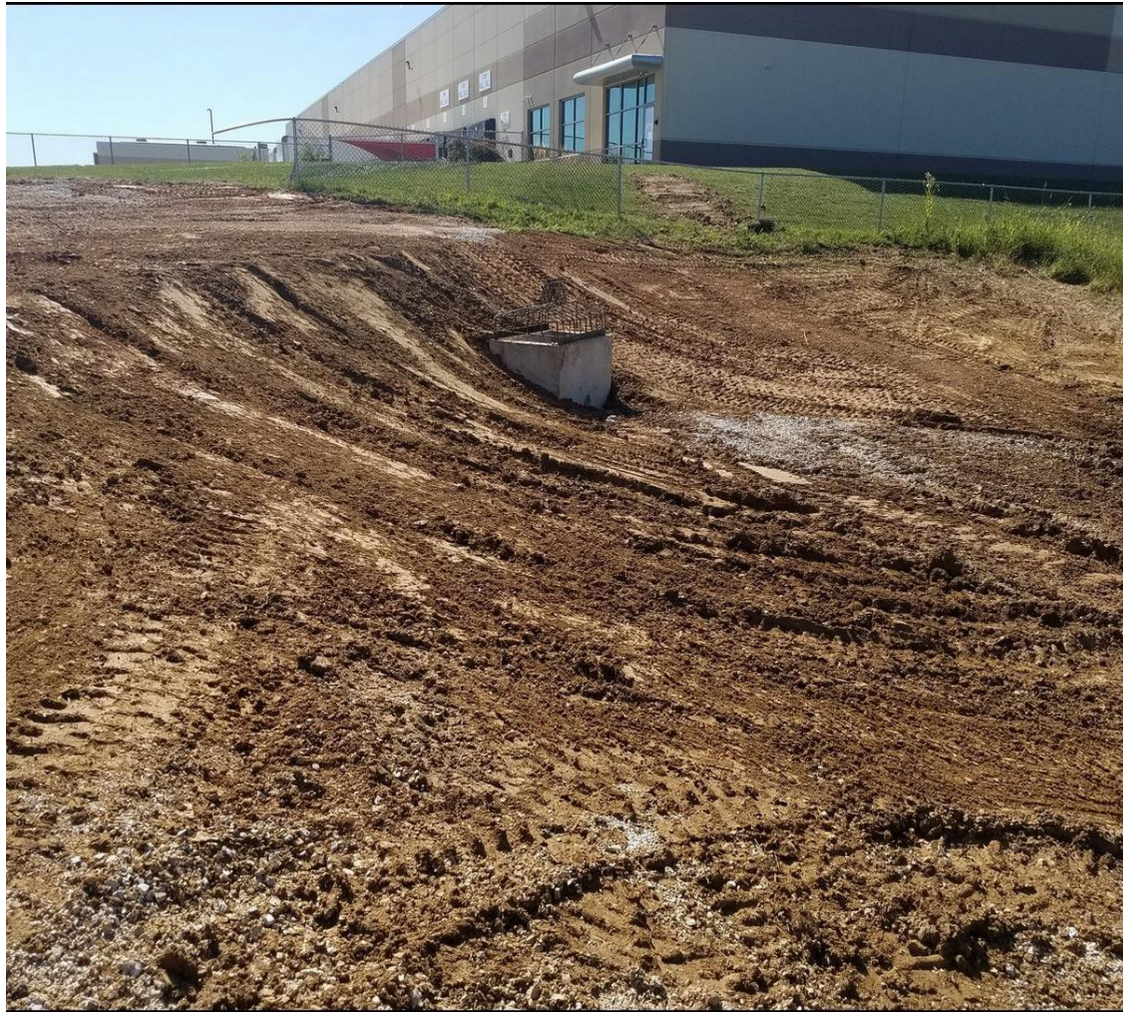
Anchor  
trench  
installed at  
top of  
slope

No new  
sinkholes  
following  
completion
